Narrowing of the Rimac River due to Anthropogenic Causes - Partial Engineering Solutions

J.M. Kuroiwa¹, A.J. Mansen², F.M. Romero³, L.F. Castro⁴ and R. Vega⁵

¹ Director, National Hydraulics Laboratory. Universidad Nacional de Ingeniería. Av Tupac Amaru 210. Lima 25. Peru. PH (51) (1) 481-1991 / 481-1920. E-mail: jkuroiwa@uni.edu.pe

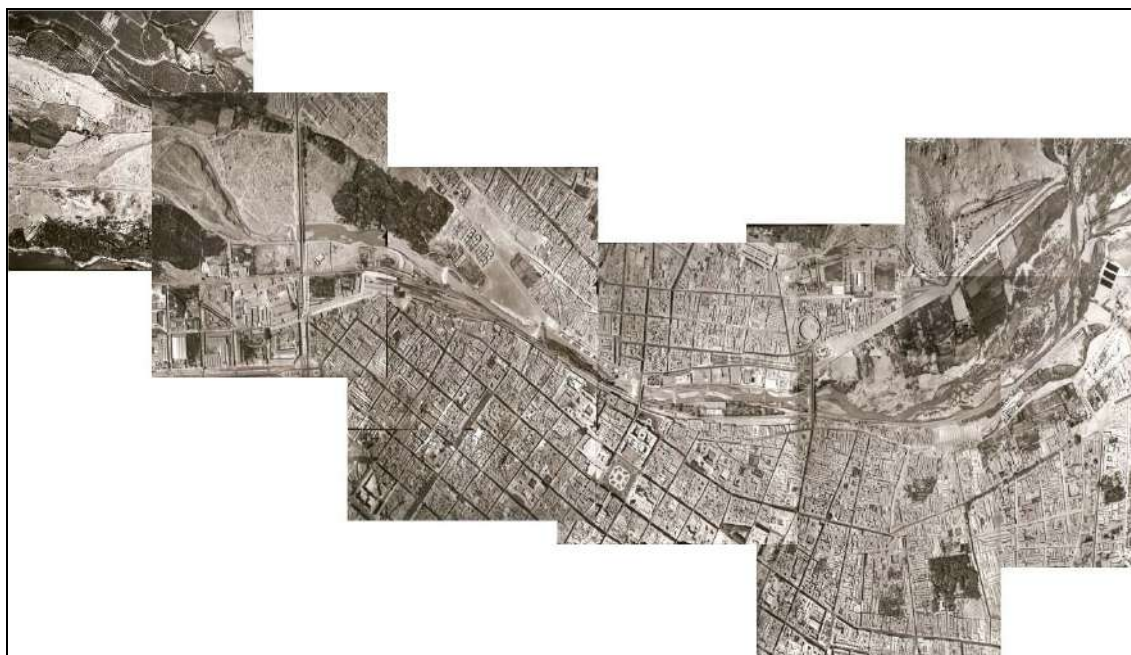
A map made at the beginning of the 20th century (Basurco, 1904) shows that reach of the river comprising sectors 1 and 2 (See Table 2) was much wider than the river upstream. Aerial photographs taken in 1944 (see Figure 1) show that the recently built “El Ejercito” Bridge (Army Bridge) had induced deepening of the river downstream of the structure. This occurred several decades after the railroad fill had partially occupied the streambed of the Rimac River and two decades before the Pan American Highway By Pass had been built. Documented evidence shows that narrowing of the Rimac River occurred after the construction of the Army Bridge, which was completed by the end of 1936.

Figure 1. Composition of aerial photographs taken in 1944. The river flows right to left. Notice the width of the river and the floodplains on the left side of the picture.

Although the Rimac River has undergone a number of modifications since the 17th century, the main cause of the formation of the Rimac River urban canyon is the construction of the Army Bridge in 1936. Aerial photographs, taken in 1944, show the recently built bridge and the early incision process downstream of the Army Bridge.

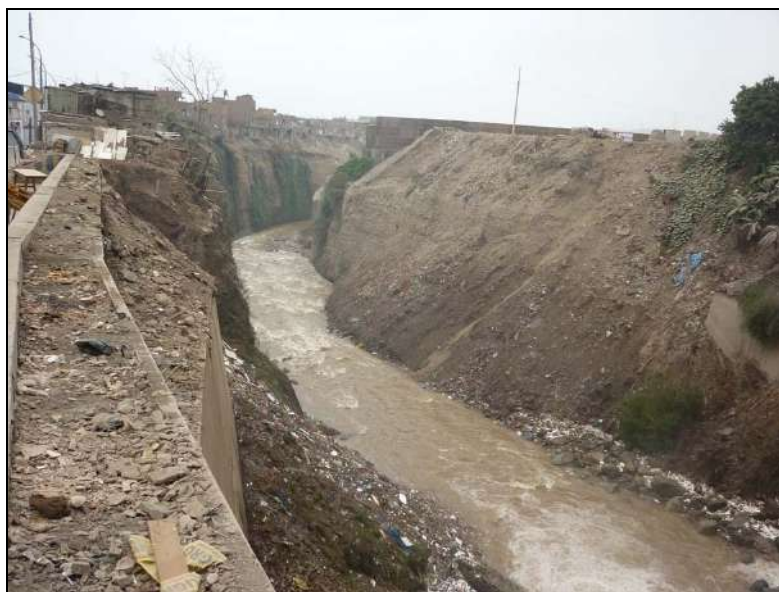
As the river became narrower and deeper, old floodplains were abandoned. This encouraged new illegal settlers to occupy the banks of the Rimac River. The cliffs are almost vertical as seen in Figure 2. Several houses have fallen because the cliffs are highly unstable. In addition, in more than one occasion, sewage from the houses directly discharging into the river had eroded away the foundation of the houses, causing the precarious structure to fall into the river. Precarious erosion control structures, such as rock deflectors, have been observed. In addition, settlers encourage garbage trucks dump sediments into the Rimac River, which somehow reduces erosion on the river almost vertical cliffs.

Figure 2. Urban canyon downstream of the Army Bridge.

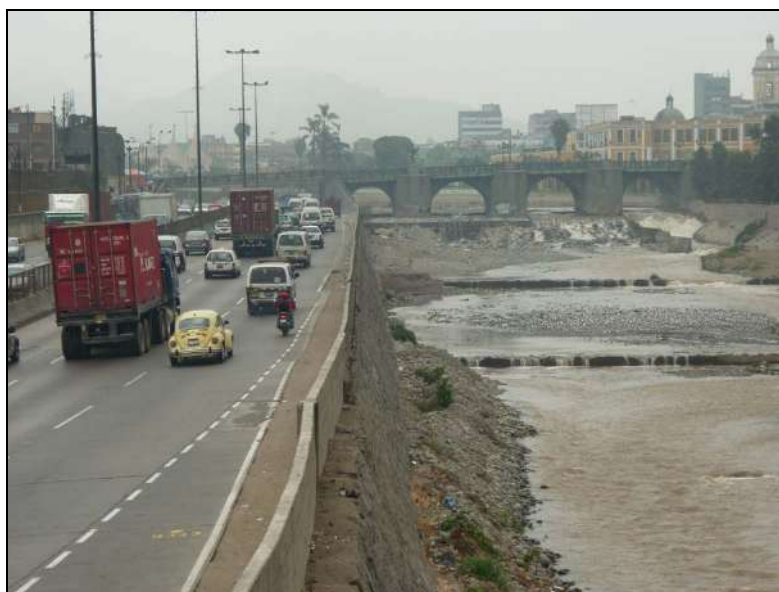
In 1968, the construction of the Pan American Highway By Pass narrowed the Rimac River near Downtown. Concrete walls were used as river training works to protect the road against flooding and erosion. The Stone Bridge and the Balta Bridge were partially demolished. Figure 3 shows the Pan-American Highway By Pass occupying part of the streambed and the right floodplains of the Rimac River. Also concrete walls one meter wide were placed as river grade controlling structures downstream of the Stone Bridge. Supposedly, they are also used to encourage infiltration into Lima's aquifer. However, no data related to aquifer recharge has been collected.

Figure 3. Construction of the Pan-American Highway By Pass narrowed the Rimac River. Notice the railroad fill on the left bank of the river. The photograph was taken looking in the upstream direction.

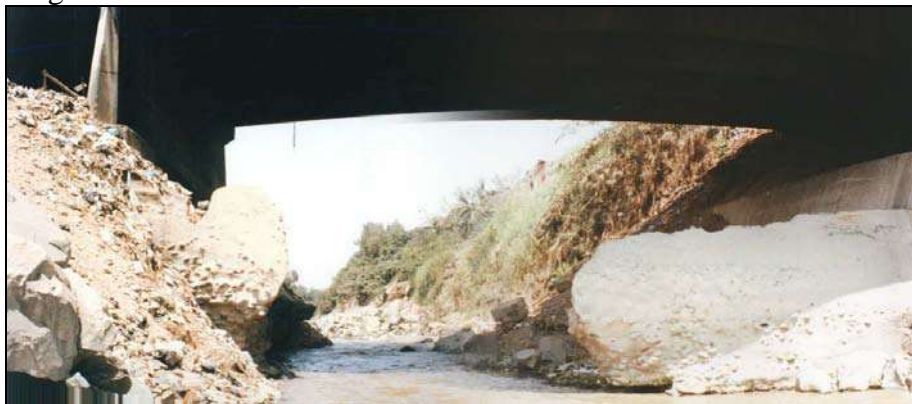
A review of photographs taken shortly after the construction of the bridge was finished, revealed that, in reality; the bridge originally had two openings in 1966 and the river width was approximately 45 m. The bridge deck laid on a central pier and two abutments. In time, deepening of the river caused that all of the flow to pass underneath the left opening. Further deepening of the river scoured the foundation of the central pier. Figure 4 shows the condition of the Dueñas Bridge in October 2001, when inspection by the first two authors of this report took place.

Figure 4. Scour under the Duenas Bridge. Notice the grade control structure built in 1977 that was completely destroyed in 2001.

Special grouting injections were used to stabilize the central pier. The hydraulic works consisted of using a broken rock ramp with a 1.33 % slope upstream of the centerline of the bridge and 3.65 % slope downstream of the centerline of the bridge. The average width of the river bed is 9.5 m. Hand placed rock walls protected the almost vertical banks of the canyon upstream of the bridge. Downstream of the bridge, riprap was accommodated to a 2H: 1 V slope where possible. D_{50} was 1.30 m. No geotextile was placed underneath the two-layer protection because the bed was mainly composed by cobbles. A paper discussing this case study was presented in Hydrology Days 2004 (Kuroiwa et al, 2004). Peak discharge between 2001 and 2009 was $142.1 \text{ m}^3/\text{s}$. The rock ramp has been stable for the last 9 years and although it was thought as a temporary solution, it has become a permanent structure. Use of dumped rock contributed to the dissipation of energy downstream of the bridge, where slope is very high. Protection of the bridge, the streambed and the banks has encouraged the illegal occupation of the right bank of the river, upstream of the bridge.

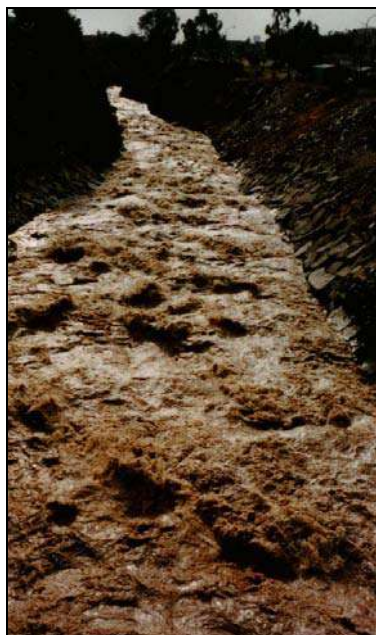
Figure 5. View of the rock ramp during a flood in March 2003.

The use of a rock ramp has stabilized the foundation of the Dueñas Bridge, located at the downstream of the study area. This solution has not produced an adversely hydraulic effect.
